Role of a sediment structure in stabilizing a mountain river after a volcanic eruption

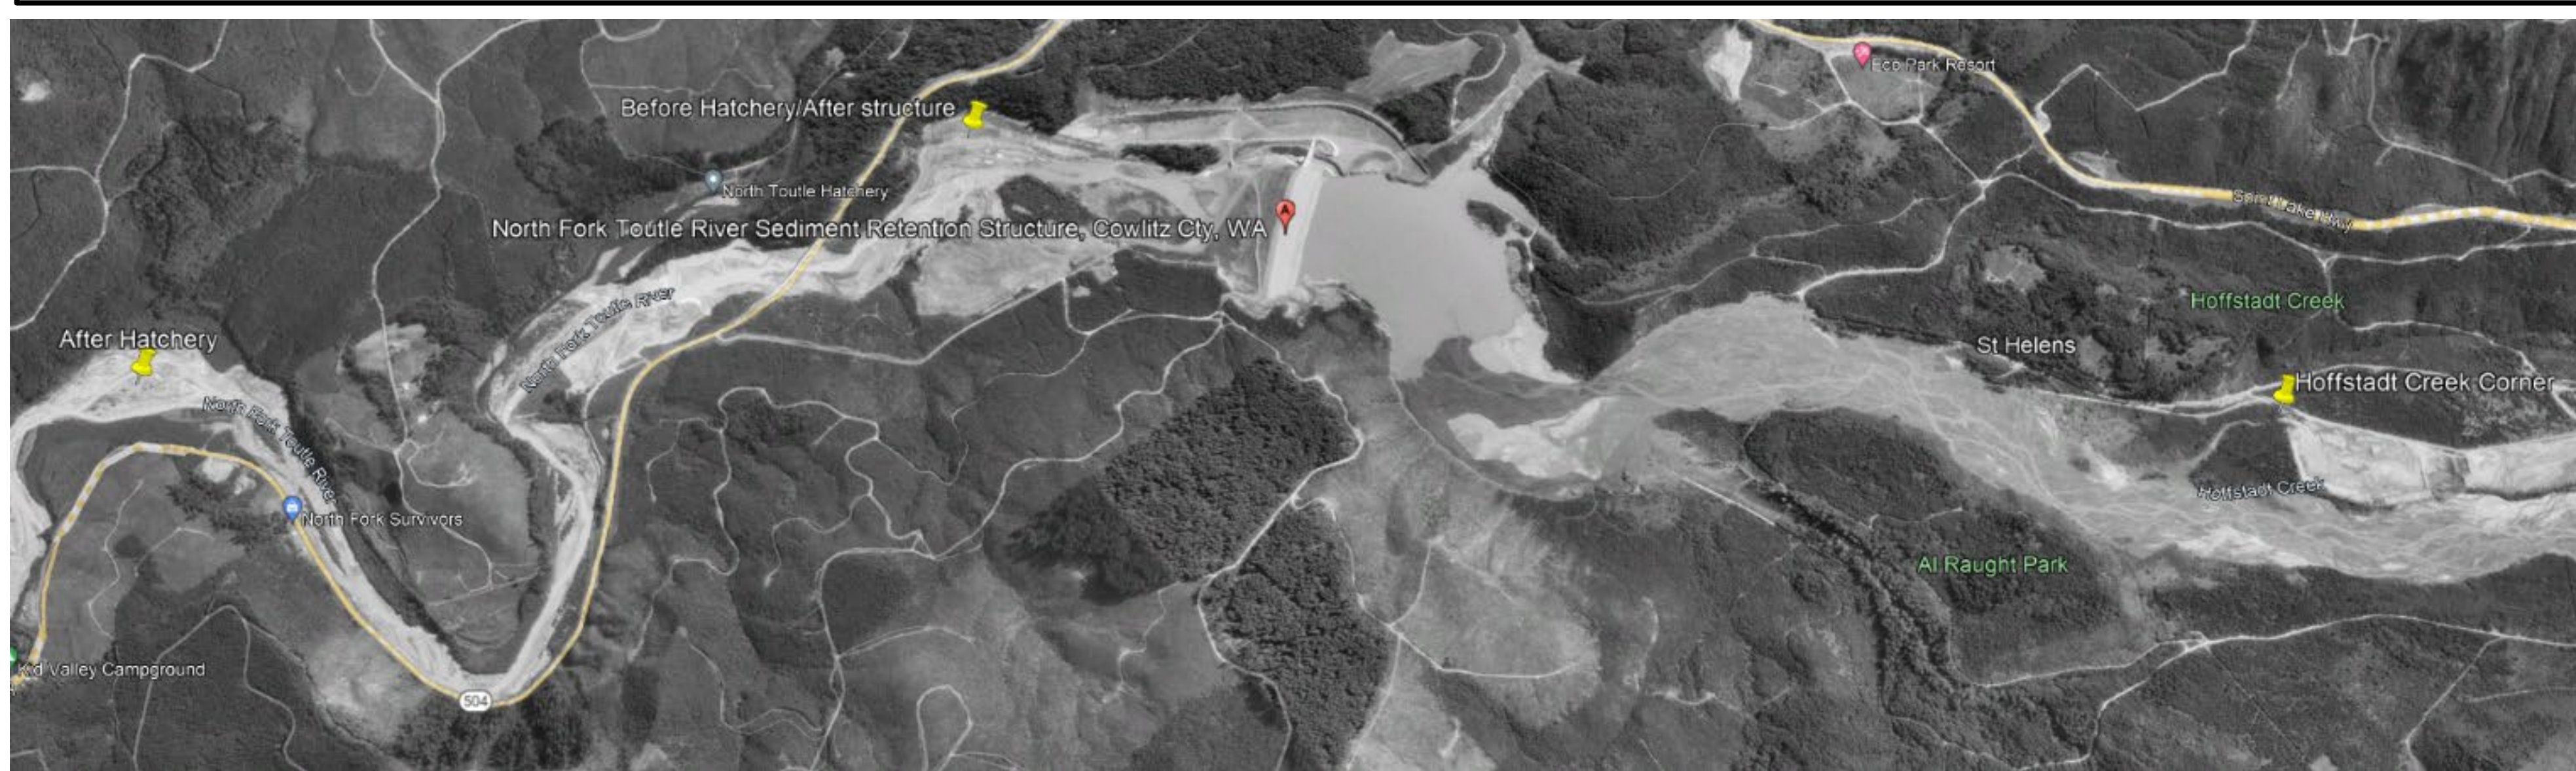
Figure 2- Google Earth Pro image of NFTR in 7/1990 right after the Sediment Retention Structure was built. The red A shows where the SRS is located on the river. The yellow pins show the location of where I mapped the vegetation and the width of the river channel.

- During 1985, Portland District of the US Army Corp of Engineers (USACE) began to develop a 50-year plan to help stop the sediment flow in the NFTR travelling further (shown in Fig 2-3)

- Mapped and recorded data from Google Earth Pro
- ◆ Mapped the Width of the river channel starting in 7/1990, 7/ 2006 and 6/2021, to show the change in kilometers post-construction of the SRS (Fig 2-3).
- ◆ Put data from mapping into bar graph (Fig. 5-6) to easier communicate that downstream is healing steadily, but upstream of SRS is still struggling.
- ◆ Mapped the Grass vegetation in acres to see how much healing has occurred since 7/1990
 - Used the years 7/1990, 7/2006, and 6/2021
- Researched and compared two other mountain eruptions that disturbed one of their nearby rivers and found a pattern (Figure 4)
 - ◆ Mount Galunggung and Mount Pinatubo
 - ◆ All 3 mountain eruptions have disturbed nearby rivers with a high volume in sediment deposits

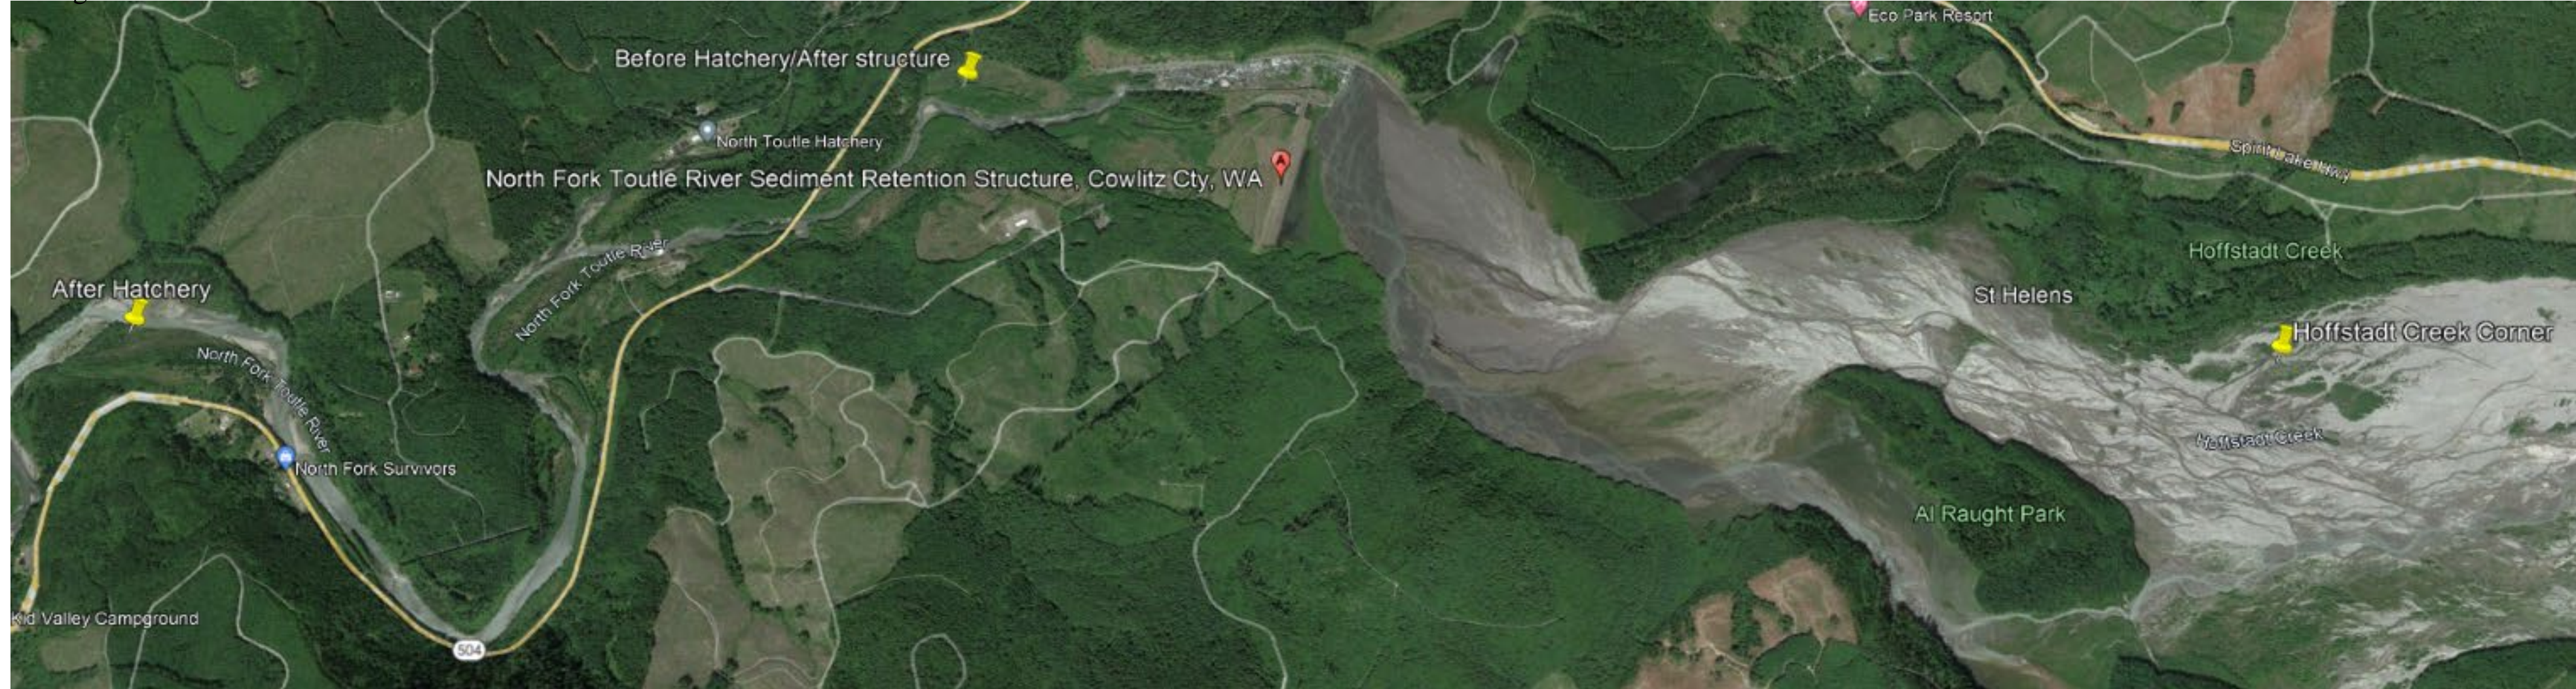
Figure 3- Google Earth Pro image of NFTR in 6/2021, thirty-one years after the Sediment Retention Structure was built. Red A shows where the SRS is located on the river. The yellow points show the locations of where I mapped the vegetation and the width of the river channel.

- This is preventing the upstream vegetation and riverbed width from healing to its previous stage.
 - Upstream is also dealing with a heavily braided riverbed channel (Figure 3)

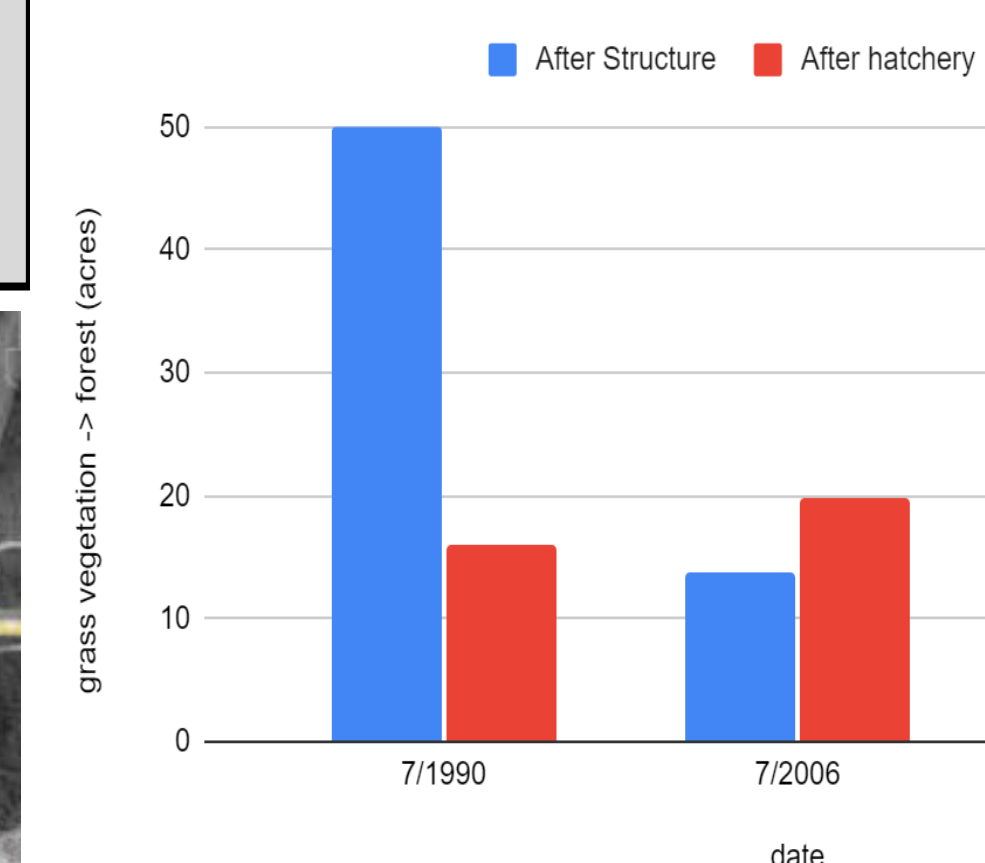
Grass -> Forest downstream

Figure 5- Grass to Forest area near the NFTR. Measured the areas of grass right before the forest line. Used the years 1990, 2006, and 2021.

- Looking at the bar graphs (Fig 5-6) it is shown that the acres of grass have declined meaning that the forest line has increased.
 - ◆ Confirms that vegetation loss is healing due to the SRS slowing of sediment

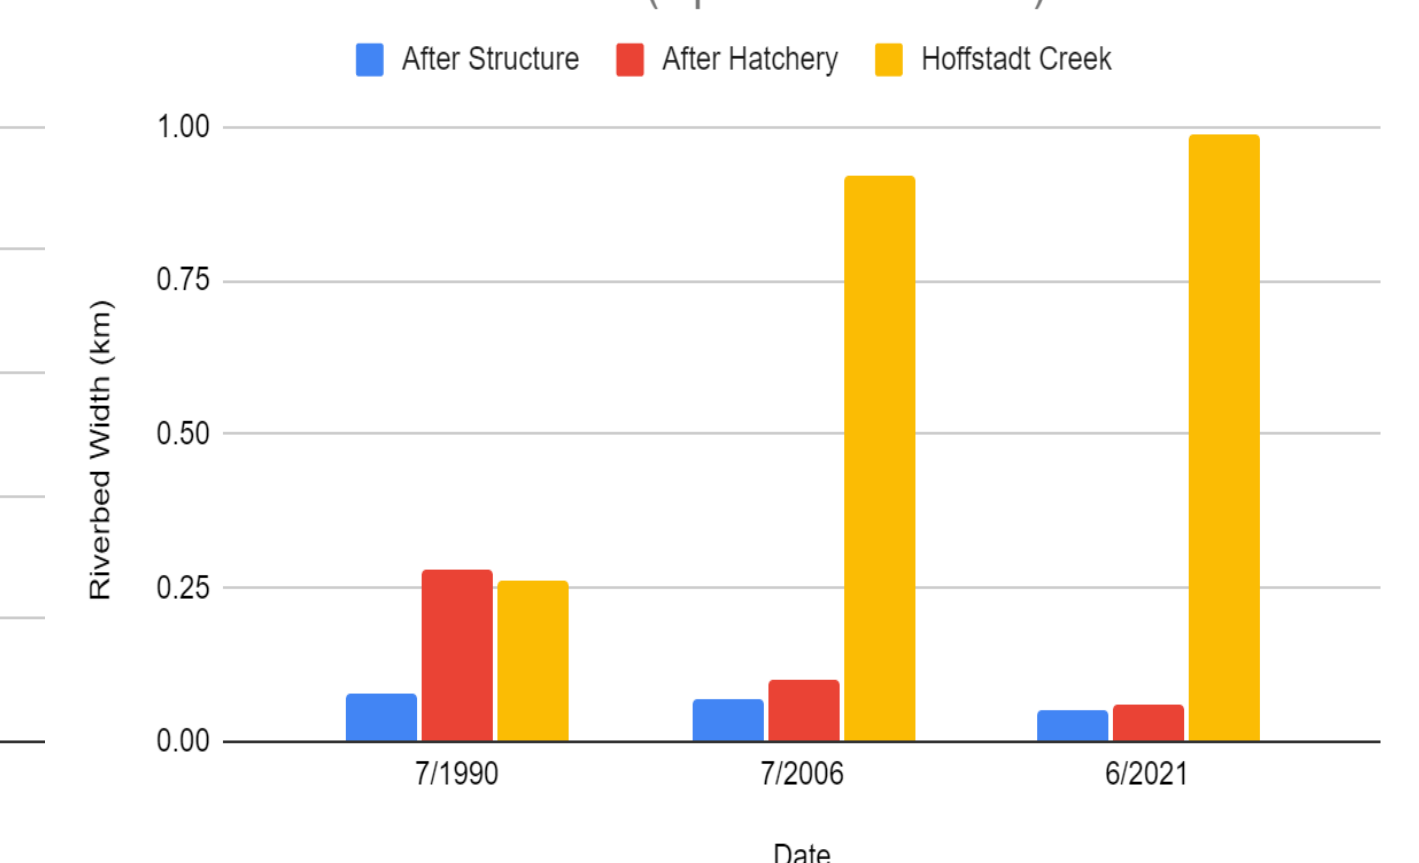
North Fork Riverbed Width (Up & Downstream)

Figure 6- The North Fork riverbed width. Measured both up and downstream in the years of 1990, 2006, and 2021.

- In Figure 6 downstream of the SRS the riverbed width is decreasing while upstream is heavily increasing.
 - ◆ Upstream is still dealing with all the sediment they are trying to slow downstream.

- ◆ Downstream is seen decreasing in width
 - Confirming that the SRS is trapping and slowing the rate of the sediment travelling downstream
- Overall, downstream the SRS is helping heal the vegetation and the riverbed as well. However, upstream is still facing a lot of problems that may take longer to fix.

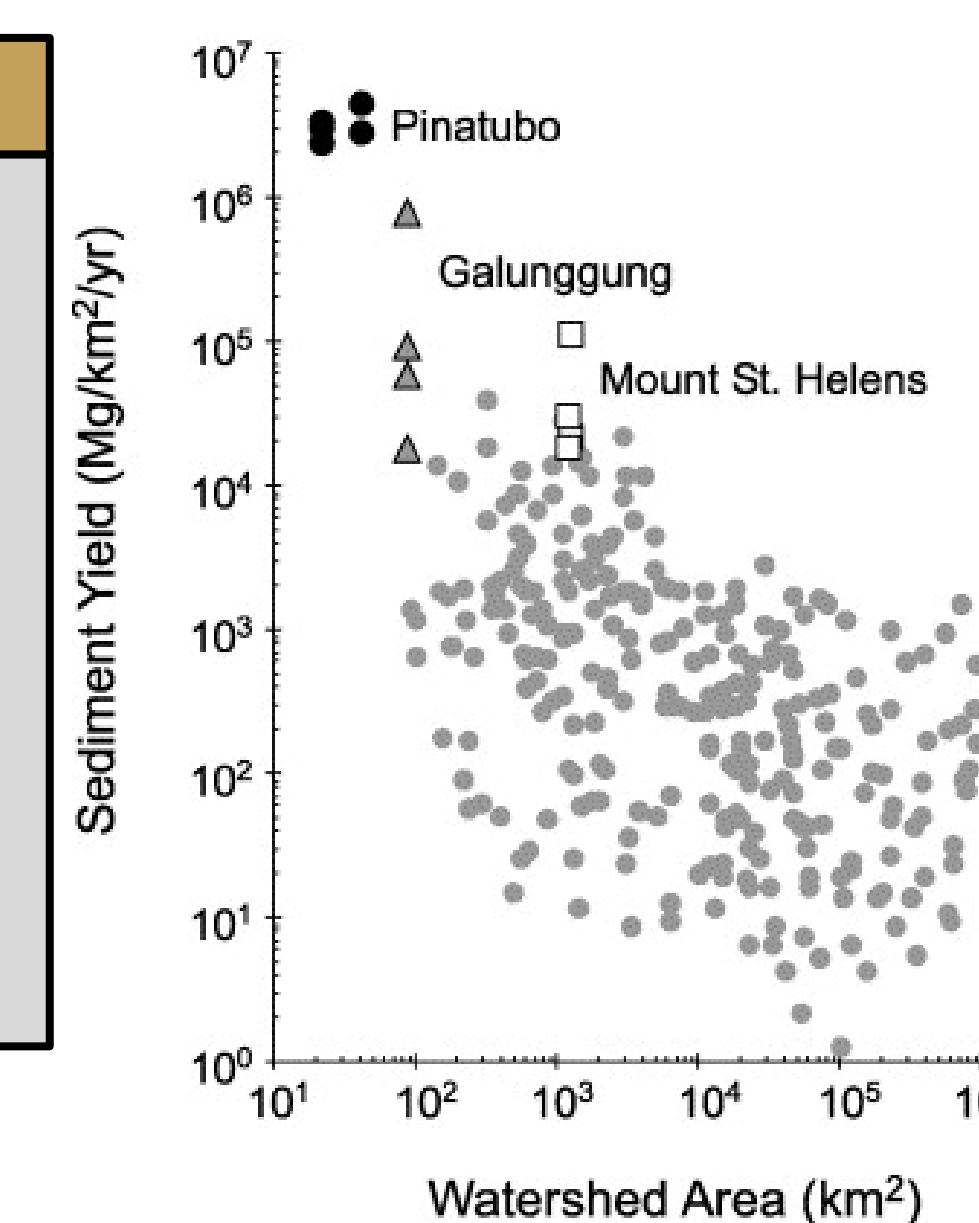
Figure 4- A graph showing the sediment yield of all three eruptions and the effect on the watershed area.
